Technical Service Bulletin

No.JTB00093
07 March 2008

Subject/Concern:	Power Steering Leak/Heavy/Noisy-Diagnostics
-------------------------	---

Models:				
X-TYPE

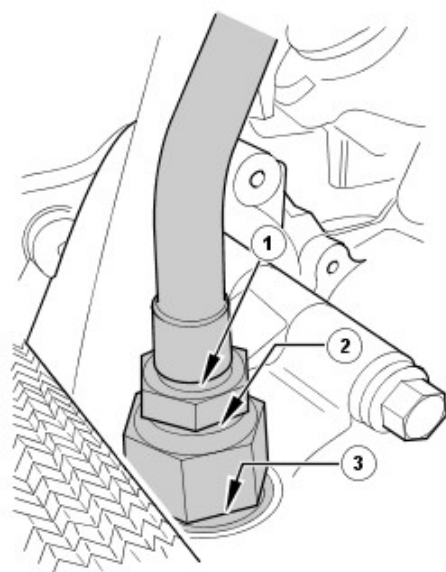
E101474

The power steering pump has several potential leak points. At the pump outlet the leak could be from three different points (see E101474).

1 Leak at the pipe o-ring in the quick connector - change pipe and connector (part number XR83295) and tighten to 57+/-3Nm.

2 Leak at the quick connector to pump adaptor - disconnect joint and renew washer (part number XR85010) and tighten to 57+/-3Nm.

3 Leak at pump adaptor to pump body - change pump but remove the quick connector from the replacement pump to allow installation of original pipe, which will retain its quick connector (tighten to 57+/-3Nm).

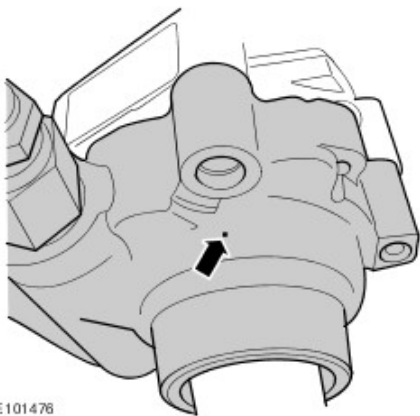
E101478

- 3 . The other common leak point is a pin-hole in the main body (see E101478).

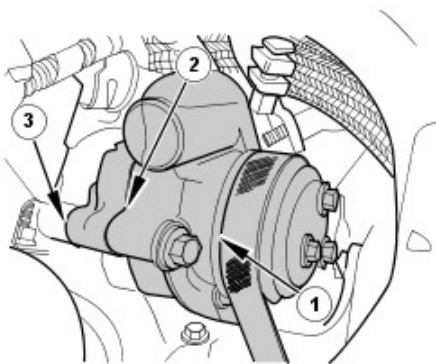
E101475

- 4 . The other potential leak points are; the front seal behind the pulley, the gasket in the middle of the pump, and the rear seal where it drives the water pump (see E101475). Particularly from the rear seal area, instances have been identified where the leak has been from the water pump and not from the power steering pump, so care should be taken over accurate identification. It is not necessary to change the power steering pump if there is only a water pump leak.
