# Technical Service Bulletin

No.JTB00055  
07 August 2007

<b>Subject/Concern:</b>	Steering Gear Squeak
-------------------------	----------------------

<b>Models:</b>		
S-TYPE		VIN-range: M45255 Onwards
X-TYPE		VIN-range: C00294 Onwards
XJ Range		VIN-range: G00442 Onwards

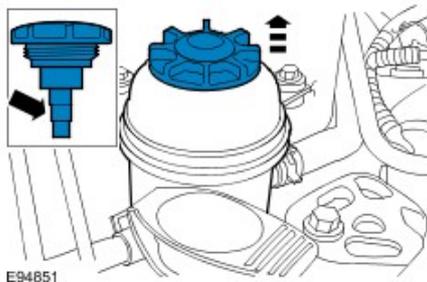
- 1 . Open driver door.
- 2 . Ensure the gear lever is in neutral/park, the parking brake is 'ON', and the ignition is 'OFF'.
- 3 . Open hood and install fender protectors.
- 4 . Remove the power steering fluid reservoir cap (and filter mesh on XJ and S-Type vehicles) and ensure the fluid level is correct.

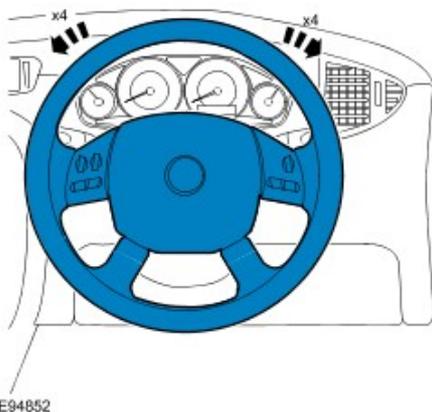
- 8 . Turn ignition 'ON' and start the engine.
- 9 . With the engine idling, turn the steering wheel from end-lock to end-lock four times (to cycle the fluid additive into the system).

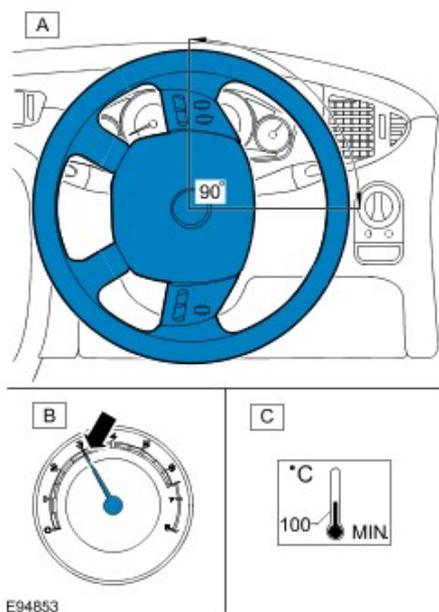
#### Heating the steering fluid to $100 \pm 5^\circ\text{C}$

While stationary and with the steering wheel in the centre position (road wheels in the straight ahead position), turn the steering wheel  $90^\circ$  (quarter turn) right and hold firmly with both hands.

1 Increase the engine speed to 3000rpm.

2 Monitor the power steering fluid temperature until  $100 \pm 5^\circ\text{C}$  is reached.

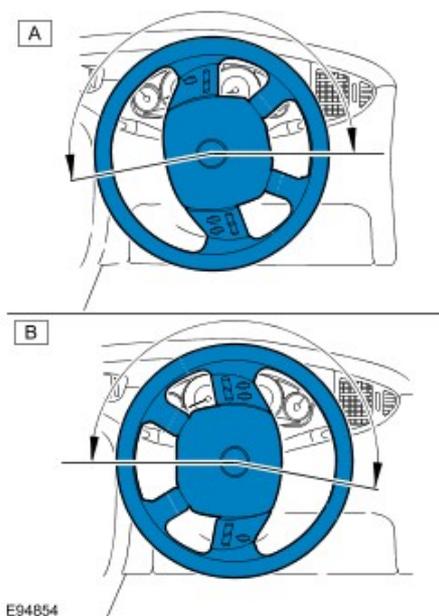
### Performing the steering manoeuvre

Turn the steering wheel to full lock and hold for two seconds. Then from full lock turn the steering wheel quickly and rapidly back a quarter ( $90^\circ$ ) turn (refer to SSM 34548 which contains a video clip showing this procedure).

- 12 . Repeat step 11 eight times.  
 13 . Turn the steering wheel to the opposite lock, and repeat steps 11 and 12.
