# Technical Service Bulletin

No.JTB00117

| <b>Subject/Concern:</b> | Transmission Rattle, Difficult Gear Change, Clutch Smell/Smoke or Unable to Select a Gear |

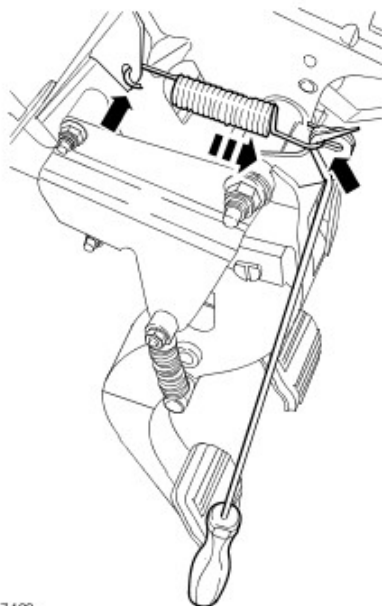
| <b>Cause:</b> Insufficient pedal return load preventing full clutch disengagement during drive. <b>Suggested Customer Concern Code - P24.</b> |

- 5 . **NOTE:** A suitable tool ('Snap On' A1710 or similar) will be required to aid with the installation of the new spring to the clutch pedal. The tool should be long enough to be used by both hands to generate enough force to expand the spring.

Install one end of the new spring to the clutch pedal housing bracket. Install the other end of the new spring to the clutch pedal bracket (see illustration E107499).
