Technical Service Bulletin

No.A308-10
20 April 2004

Subject/Concern:	Clutch Pedal Squeak
-------------------------	---------------------

Models:		
X-TYPE	2.2L Diesel Only	2.2L Diesel Only VIN-range: E73994-E99675

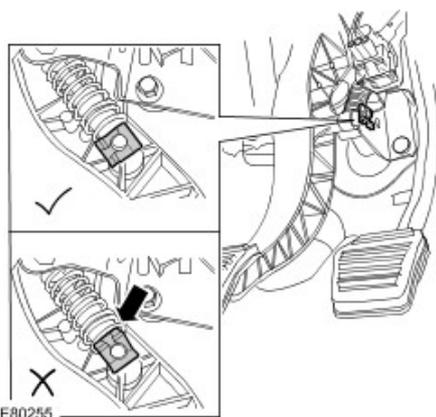
Summary:
This bulletin addresses customer concerns of a squeaking/creaking noise from the clutch pedal when operating.
Cause: Foul condition between the clutch pedal retaining clip and lower spring retainer.
Action: Should a customer express concern, correct the alignment of the clutch pedal retaining clip. Follow the Service Instruction outlined below.

- 1 . Open driver door.
- 2 . Inspect clutch pedal retaining clip against illustration E80255 to confirm foul condition.

- 3 . Rotate the clutch pedal retaining clip through 90 degrees so the foul condition is removed (see illustration E80255).
- 4 . Close driver door.
