TECHNICAL BULLETIN

No: JTB00183

SECTION: 412**Air Conditioning System Not Cooling Sufficiently****AFFECTED VEHICLE RANGE:**

MODIFY AIR CONDITIONING COMPRESSOR VALVE SPRING

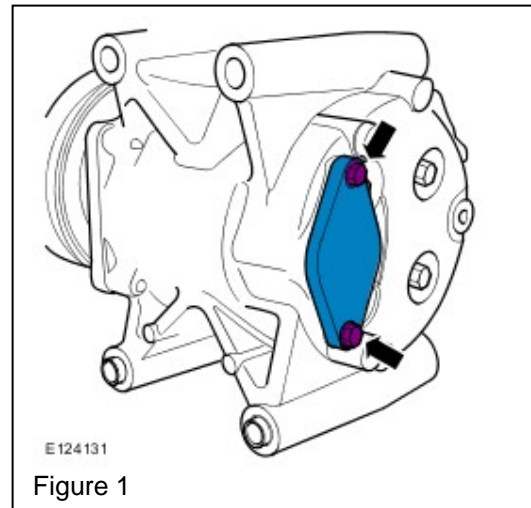
NOTE: A/C compressor shown removed for clarity.
Note the position of the cover. (Figure 1)

4. Remove the A/C compressor valve cover:
 - Remove the two bolts.

- Evenly and progressively tighten the bolts to **15Nm (11 lbf ft)**. (Figure 1)

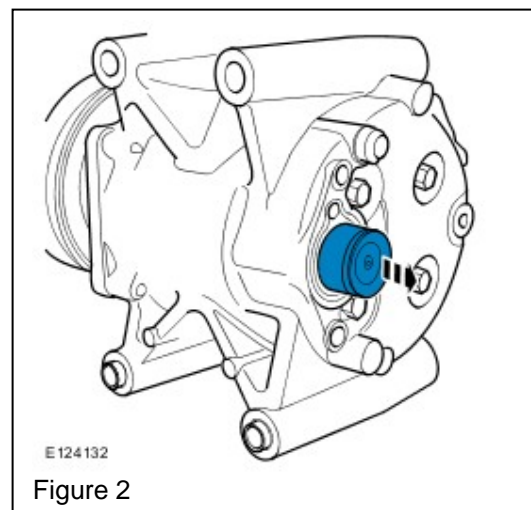
NOTE: Note position of the A/C compressor valve.
(Figure 2)

5. Remove the A/C compressor valve. (Figure 2)
